# Addressing Environmental Preservation through Our Business Activities

## Measures to Control Soil and Groundwater Contamination

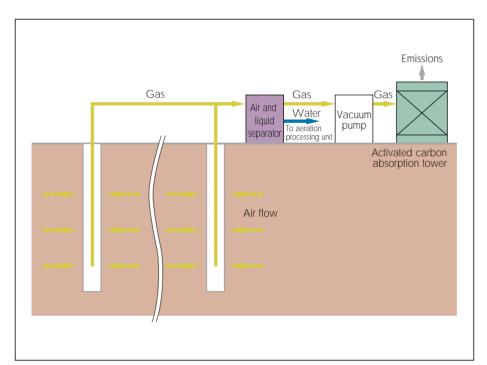
#### \*1. Strong vacuum extraction and activated carbon absorption process

A well drilled for remediation of a contaminated area is decompressed with the installation of a vacuum pump. Any chlorinated organic solvents in the soil are extracted by means of gasification. The recovered gas is processed by means of absorption with activated charcoal.

We have instituted purification facilities on polluted sites and, wherever it was deemed necessary as part of the cleanup operation, we drilled wells along the borders of the sites of plants and subsidiaries. We have also prevented the spread of contamination beyond the sites by actively cleaning polluted soil and groundwater by means of strong vacuum extraction and the activated carbon absorption process\*1 and by the water pumping, aeration, and activated carbon absorption process.\*2

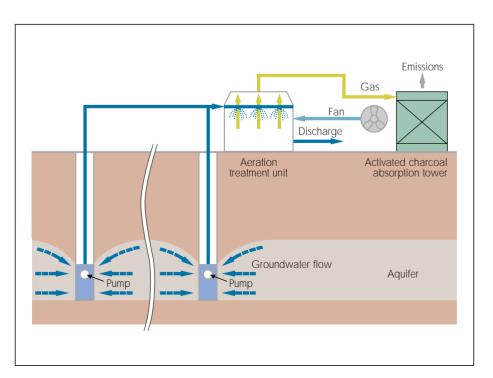
# \*2. Water pumping, aeration and activated carbon absorption process

Groundwater is pumped up with a pump installed in a well used for remediation of a contaminated area. The recovered water is aerated and the chlorinated organic solvent is isolated by means of gasification. The treated water is discharged into the sewerage or a river when the contaminant has been reduced to less than one-half the environmental standard. The gasified chlorinated organic solvent is processed by means of absorption with activated charcoal.
